Uncontrolled closure of a hatch cover resulting in one crew fatality on the cargo vessel *SMN Explorer* Alexandra Dock, King's Lynn on 1 February 2018

SUMMARY

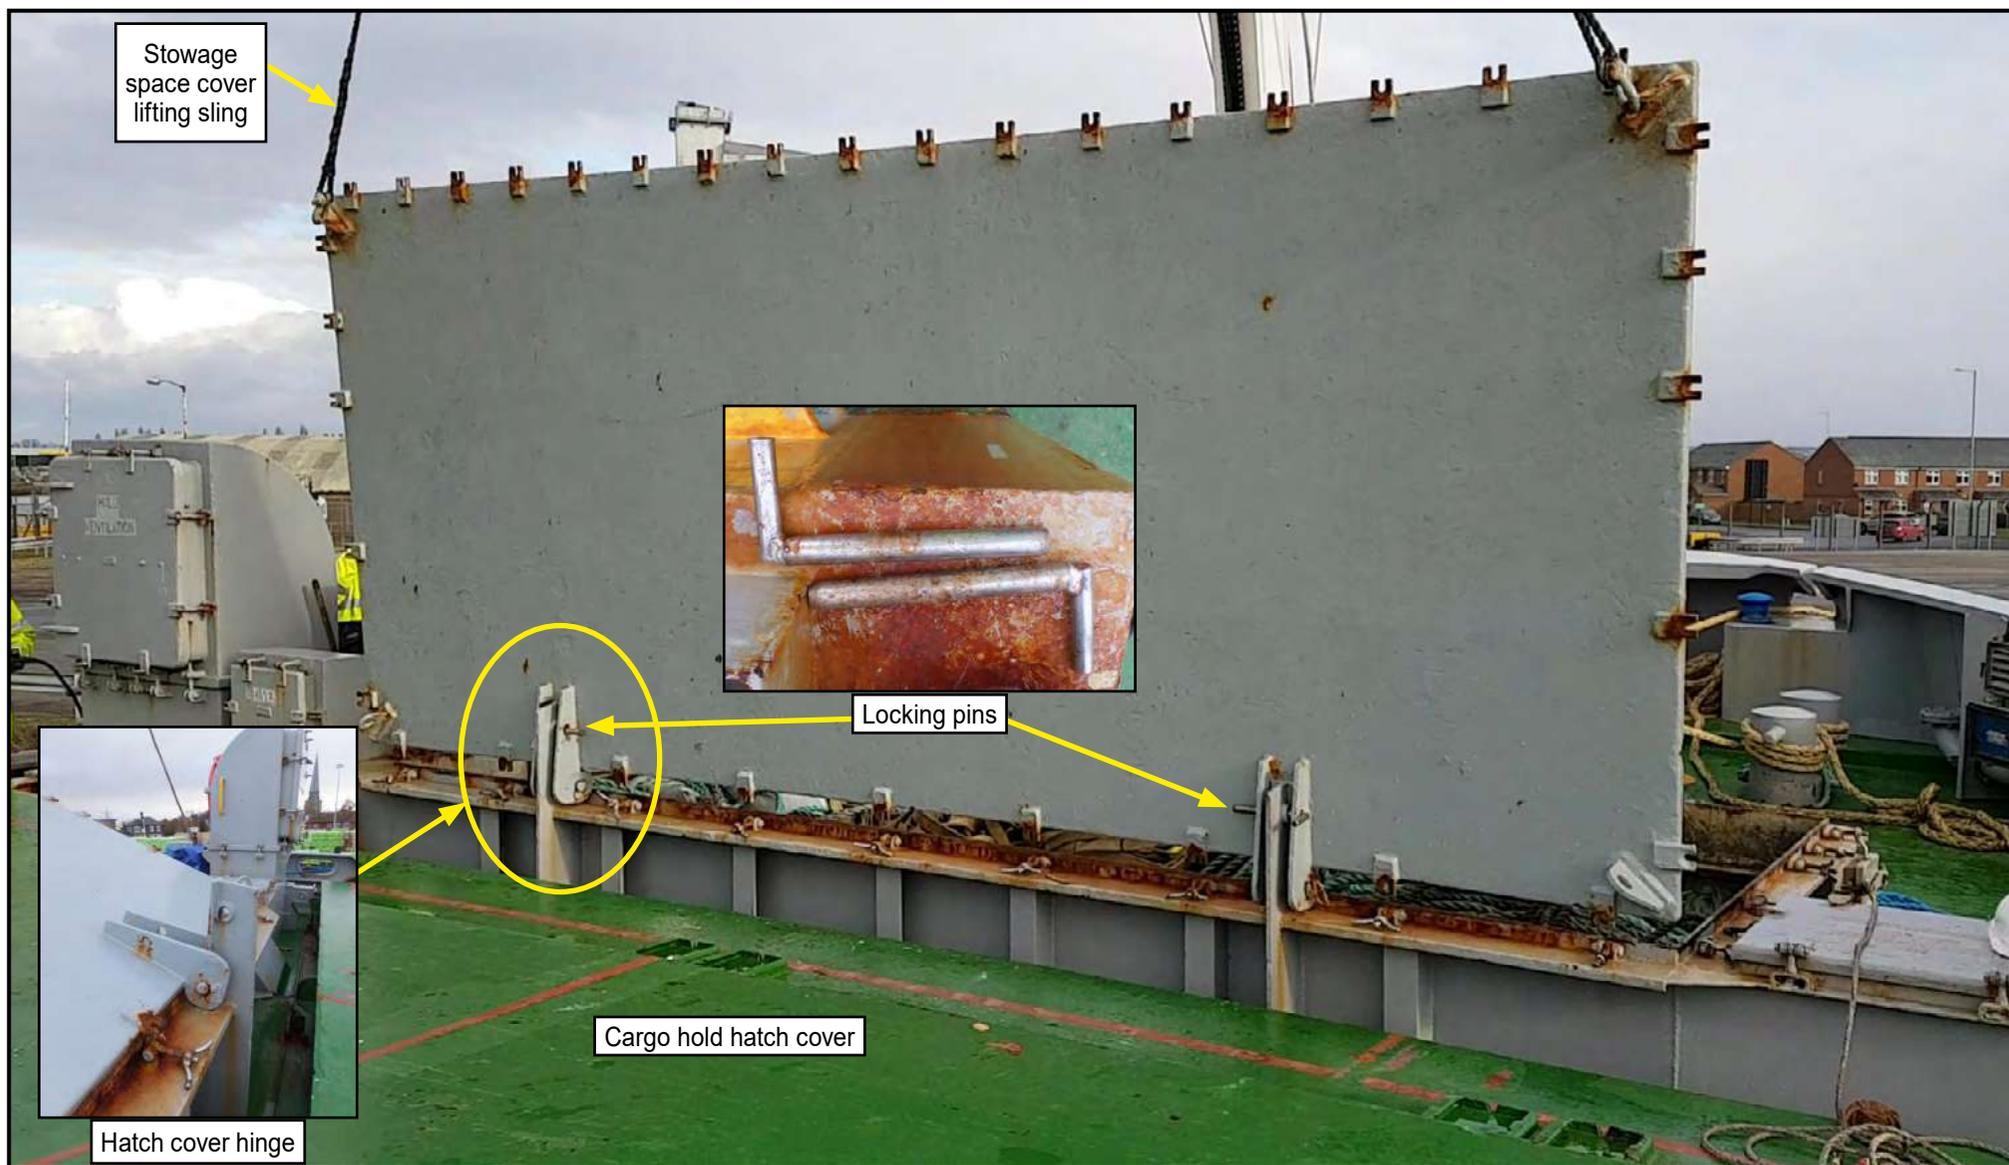
Figure 1: Stowage space hatch cover in opened position

In the open position, the hinged cover rested in a vertical position on its backstops and was locked in place by two locking pins. The stowage space hatch cover's original locking pins had been discarded due to corrosion, and new pins were on order. As an interim measure, the crew used the anchor guillotine locking pins to secure the cover in its open position.

The hatch cover fell on top of Alfred because he put his weight on the inside of the open cover after its locking pins had been removed and before the crane hook had been attached to the lifting slings and tensioned. This procedural lapse occurred because a safe system of work had not been developed for opening and closing the hatch cover and because the operation was not properly supervised. Factors that contributed to this include:

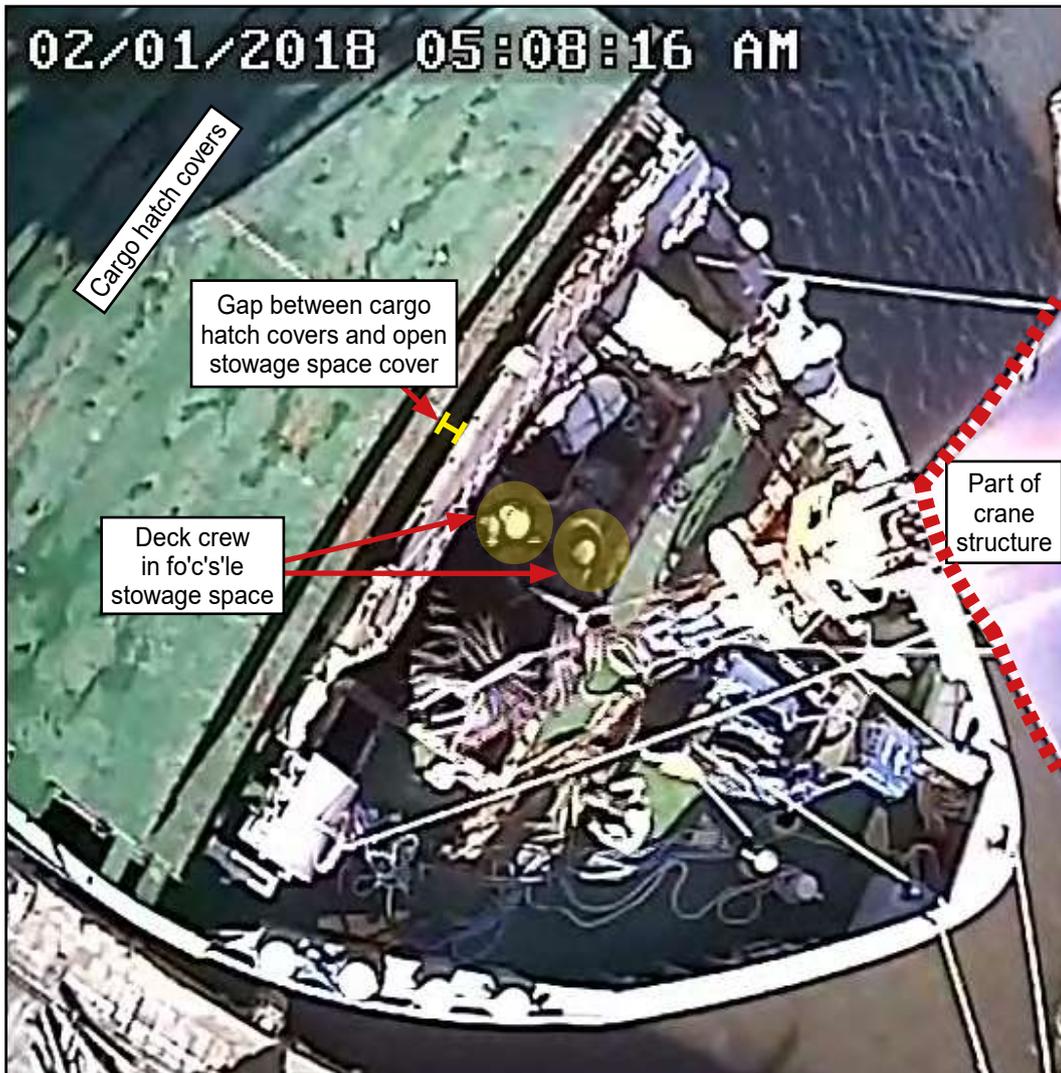
Figure 2: Snapshot taken from dockside crane camera

As the C/O lowered the crane hook, Alfred climbed over the fo'c's'le stowage space hatch combing and walked over the cargo slings to the hatch cover. Alfred then climbed up the inside of the hatch cover, using the framing as hand and foot holds, and reached up to grab the lifting slings (**Figure 3**). As he did so the hatch cover fell forward, trapping him between the hatch cover and the hatch coaming.

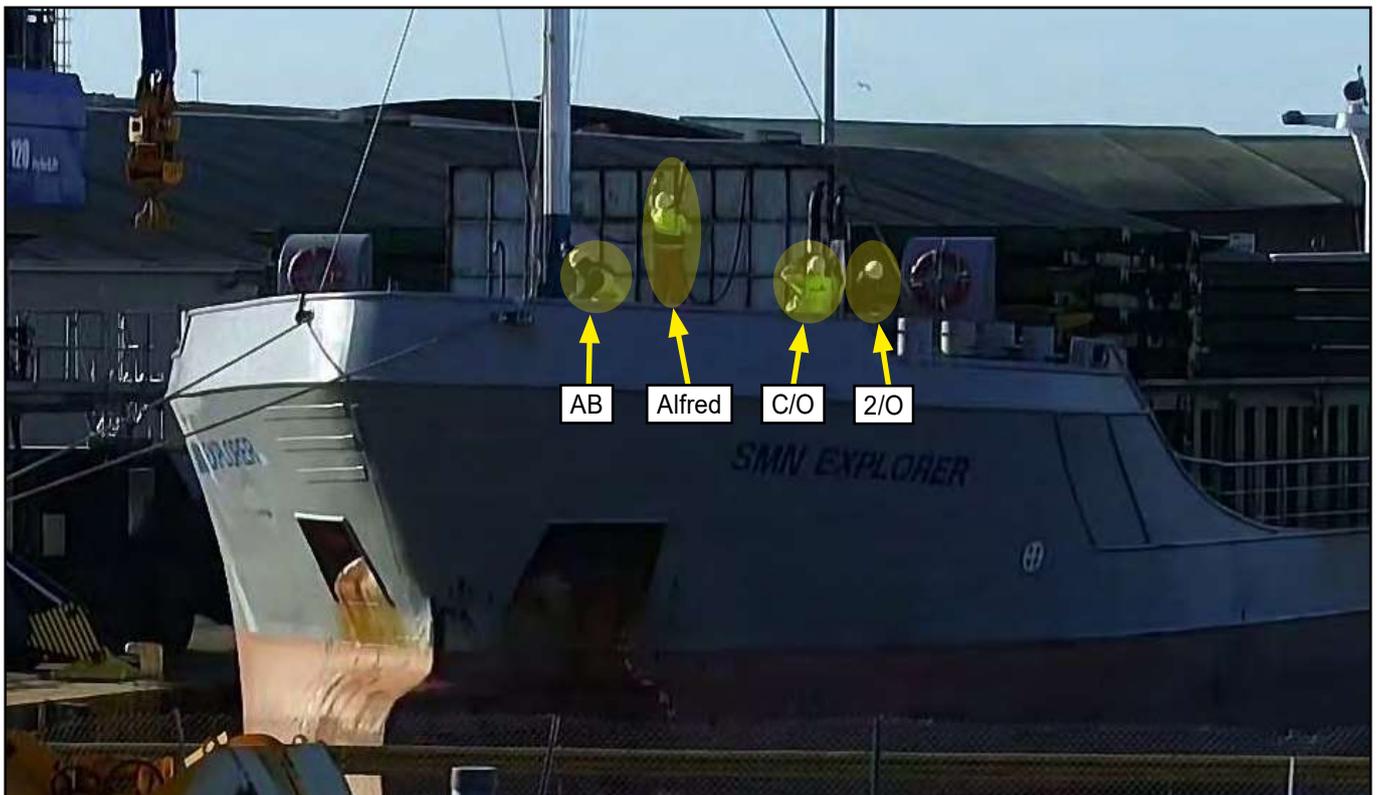
Figure 3: Position of the deck crew as Alfred climbed up the underside of the stowage space cover

The C/O had a clear view of the stowage space and his deck crew when the hatch cover locking pins were removed, and was aware that one of his ABs would need to climb up the inside of the hatch cover to unhook its lifting sling ring. However, the C/O did not realise that the locking pins had been removed when Alfred approached the hatch cover. This was because he and the 2/O were focusing on the operation of the foremast crane when the ABs removed the locking pins.

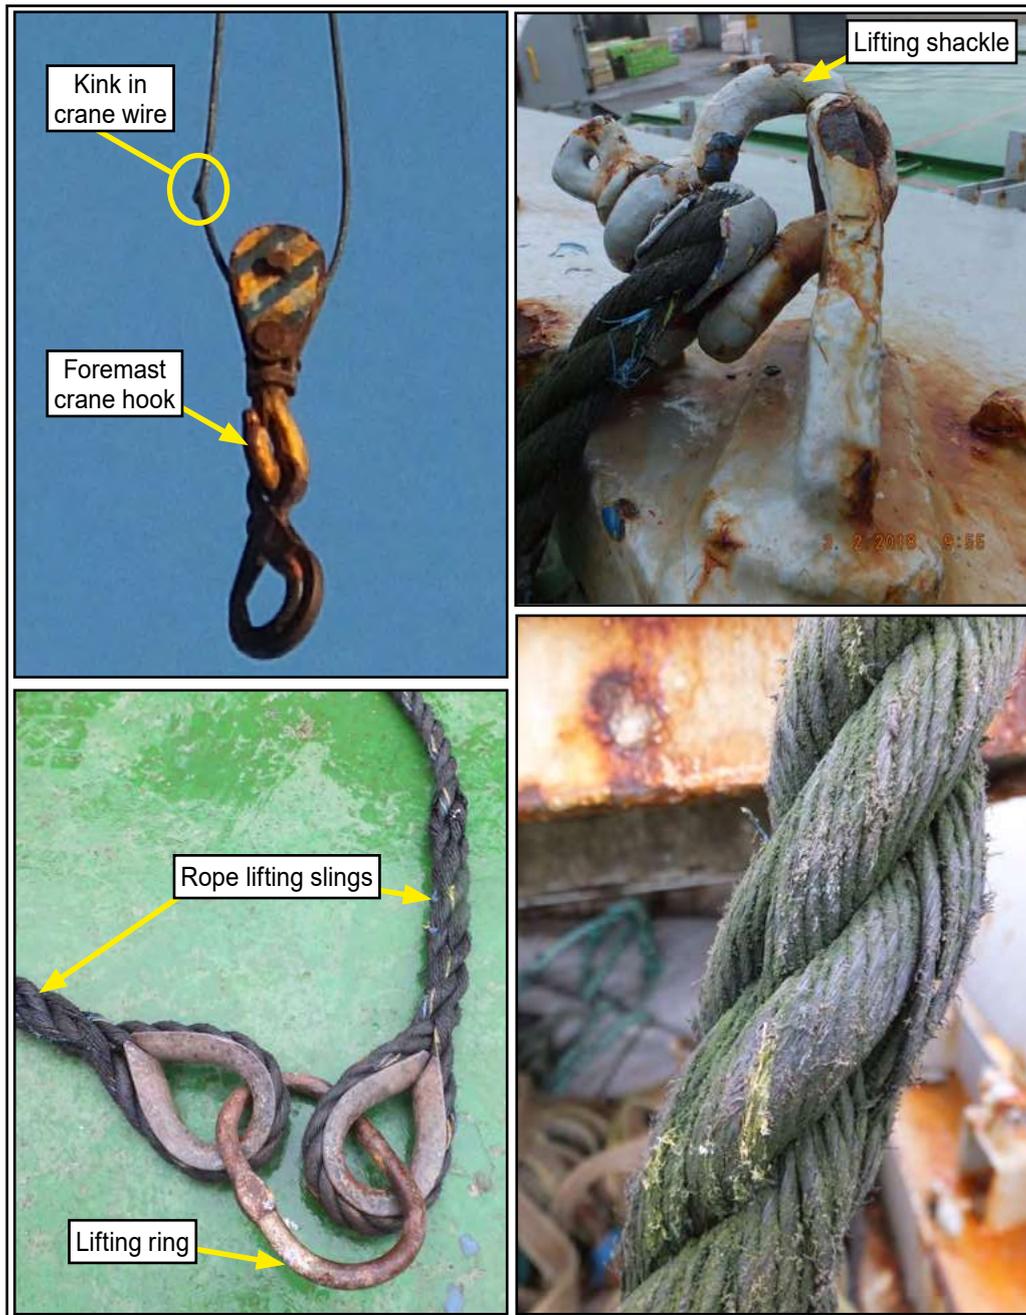
Figure 6: Stowage space cover lifting gear

- Numerous hand and foot marks were present on the stowage space hatch cover's internal frames.
- The anchor guillotine locking pins were a loose fit in the hatch cover and backstop locating holes, and had no means of being locked in place.
- The rope lifting slings appeared to be in poor condition.

- Much of the lifting gear examined on the fo’c’s’le deck was found to be in a similarly poor state (**Figure 6**).
- There was no lifting appliance register on board.

SMN Explorer did not have on board any records or certification for the lifting equipment used to open and close the hatch cover. The foremast crane was marked with an SWL of 0.9 tonne but there was no valid certificate of examination or test held on board the vessel. The lifting slings and shackles were not marked with SWL or identification numbers.

The opening and closing of the fo'c's'le stowage space hatch cover was a lifting operation and, as such, it should have been properly planned and executed. Furthermore, the equipment used to lift the cover should have been subject to strict maintenance and testing routines that should have been recorded in a lifting appliance register. This was not the case; the SMS contained no guidance for planning lifting operations or the maintenance of lifting equipment. The vessel held no certification for the foremast crane and the condition of much of the lifting gear inspected by the MAIB was poor.

| 2018/135 | Ensure that <i>SMN Explorer</i> and all its managed vessels have systems in place to manage and record the maintenance of lifting appliances. |

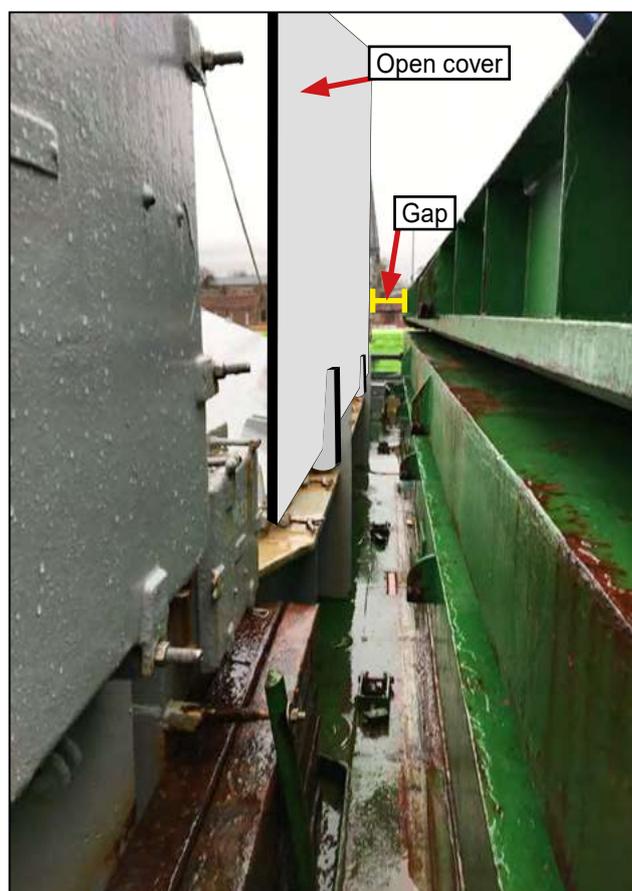
Figure 7: Gap between the open stowage space cover and the stacked cargo hatch covers

After the accident, the C/O wrote and demonstrated a procedure that removed the need to enter the stowage space while opening and closing its hatch cover. The revised procedure required the crew to climb on top of the cargo hold hatch covers instead. This procedural approach might seem obvious; it certainly removed the need to enter a potential danger zone, walk on uneven surfaces and climb up the underside of the cover. Nevertheless, it is understandable why this procedure was not adopted previously by *SMN Explorer's* crew. On the day of the accident four of the vessel's cargo hold hatch covers had been stacked on top of each other behind the fo'c's'le stowage space. This made access behind the open cover difficult (**Figure 7**). On other occasions the forward cargo hold hatch covers could be stowed aft, creating a serious fall hazard.

| 2018/134 | Take appropriate action to remove the need for deck crew to climb onto the stowage hatch coamings and cover, and walk across uneven surfaces to routinely attach and disconnect the foremast crane hook. |
