SAFETY INVESTIGATION REPORT

REPORT NO.: 23/2018

MV EUGENIA B **Fatal fall of a stevedore inside cargo hold no. 2** **in the port of Iskenderun** **30 November 2017**

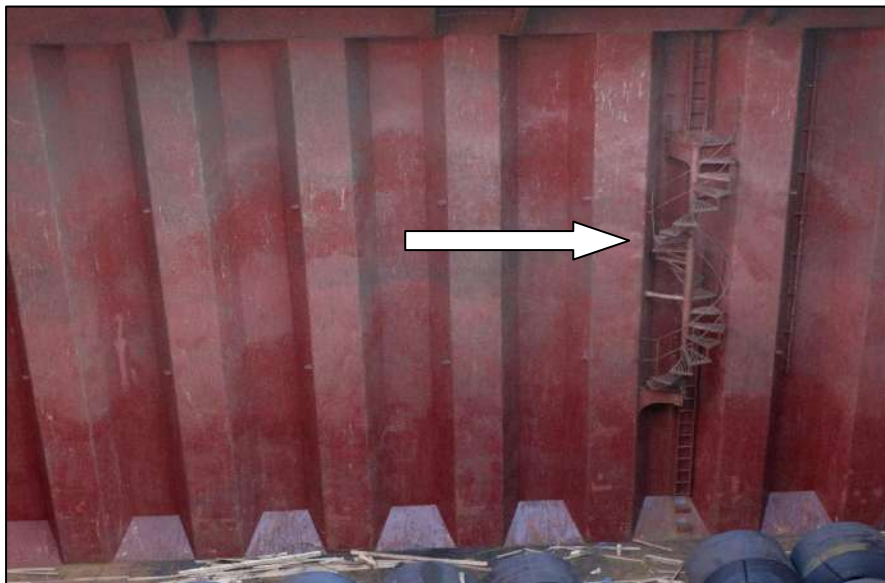
Figure 1: Access to cargo hold no. 2

The accident happened in cargo hold no. 2, which is fitted between frames 143 and 179. Access to the cargo hold is down a combination of vertical and spiral ladders fitted against the forward corrugated, transverse bulkhead³. The total height from the main deck down to the tanktop was 16.0 m. The ladder (Figure 1) was constructed in sections:

- A vertical ladder of two meters in length (access from the main deck booby-hatch), leading to the upper landing;
- A step to the side on the upper landing, leading to the second vertical ladder, through a hatchway (65 cm by 65 cm), of three meters in length and leading down to the middle landing; and
- A spiral ladder, six metres in length followed by a lower vertical ladder, which was four meters long and which led down to the cargo hold's tanktop.

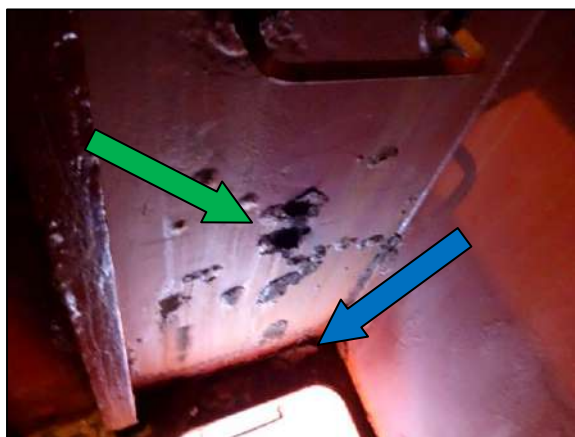
An inspection of the cargo hold access cover indicated it was also designed to help a person climb the vertical ladder. A stopper pin was fitted to keep the cargo hold access cover secured and in a vertical and open position. The MSIU found that the cargo hold access cover's stopper pin had been totally dislodged and the hinges had failed (Figure 2), in all probability while the stevedore was climbing out of cargo hold no. 2⁵.

Figure 2: Broken stopper (green arrow) and broken hinges (blue arrow)

It was clear to the safety investigation that the hinges and stopper failed while the stevedore was climbing his way up from the cargo hold. Moreover, the most logical sequence of events was for the stopper pin to fracture first, followed by the hinges (unless the hinges had already corroded away prior to the accident).

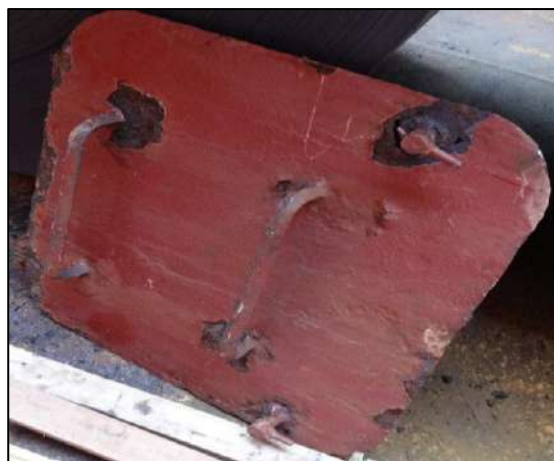
The cargo hold access cover had signs of general corrosion. Material wastage was evident, suggesting that it had not been maintained over the months prior to the accident (Figure 3).

Figure 3: Cargo hold access cover as found at the bottom of the cargo hold.

23/2018_R1 review its planned maintenance regime within the safety management system of the Company, to ensure that critical fittings inside the cargo holds are also thoroughly inspected and maintained, as necessary;

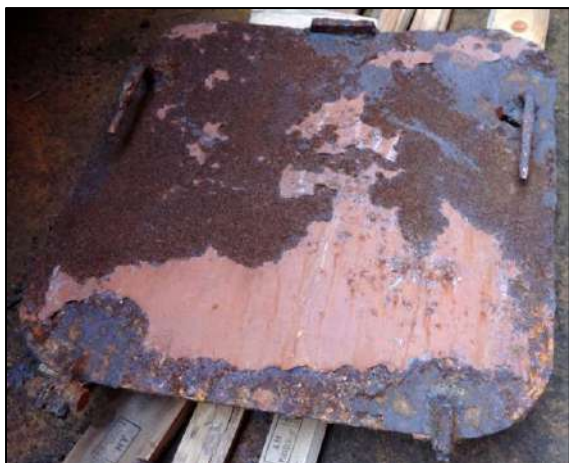
The safety investigation estimated that the back side of the cargo hold access cover had a 70% uniform loss of the metallic surface (Figure 4).

Figure 4: Material wastage signs and failed of hinges

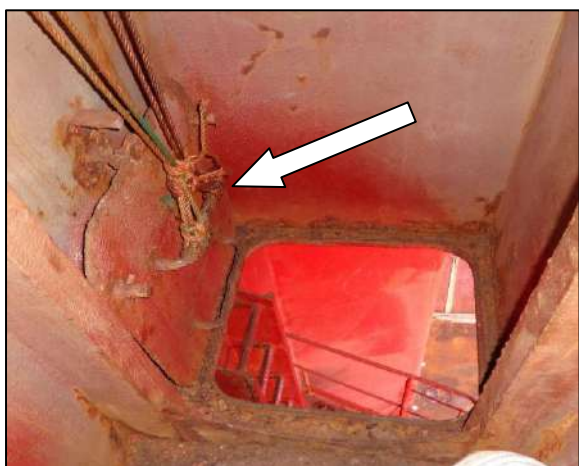
An additional cargo hold access cover was inspected during the course of evidence collection on board. The cargo hold access cover fitted in cargo hold no. 4 was found in a similar (poor) condition to that in cargo hold no. 2 (Figure 5).

Figure 5: Cargo hold access cover in way of cargo hold no. 4

Taking into consideration the condition of all the inspected cargo hold access covers, the safety investigation concluded that the covers had not been thoroughly inspected as part of a maintenance regime applied on board and may have even been missed, given that they were rarely used and always kept in the open position.

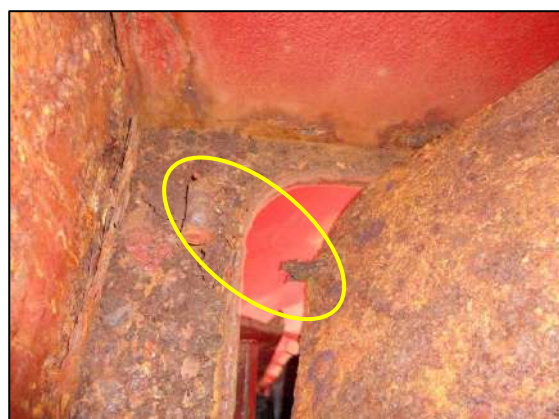
A closer, visual inspection revealed that the stopper and the hinges were rusty and broken (Figures 6 and 7).

Figure 6: Broken hinge

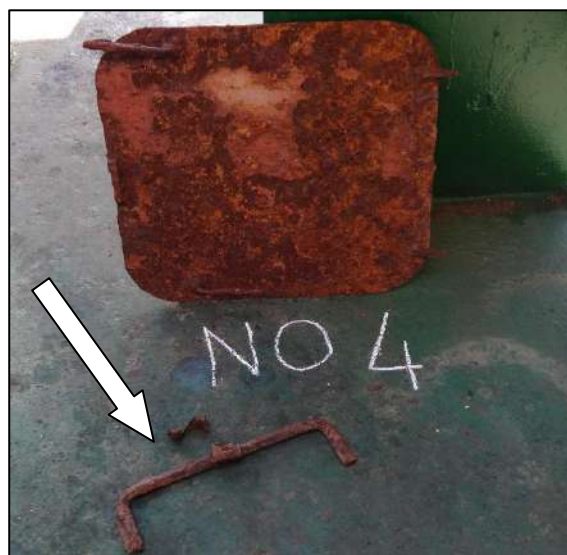
Figure 7: Broken stopper
