## MARINE SAFETY INVESTIGATION REPORT

Safety investigation into the fatality of two crew members  
on board the Maltese registered chemical tanker

### ***KEY FIGHTER***

MARINE SAFETY INVESTIGATION REPORT NO. 15/2019

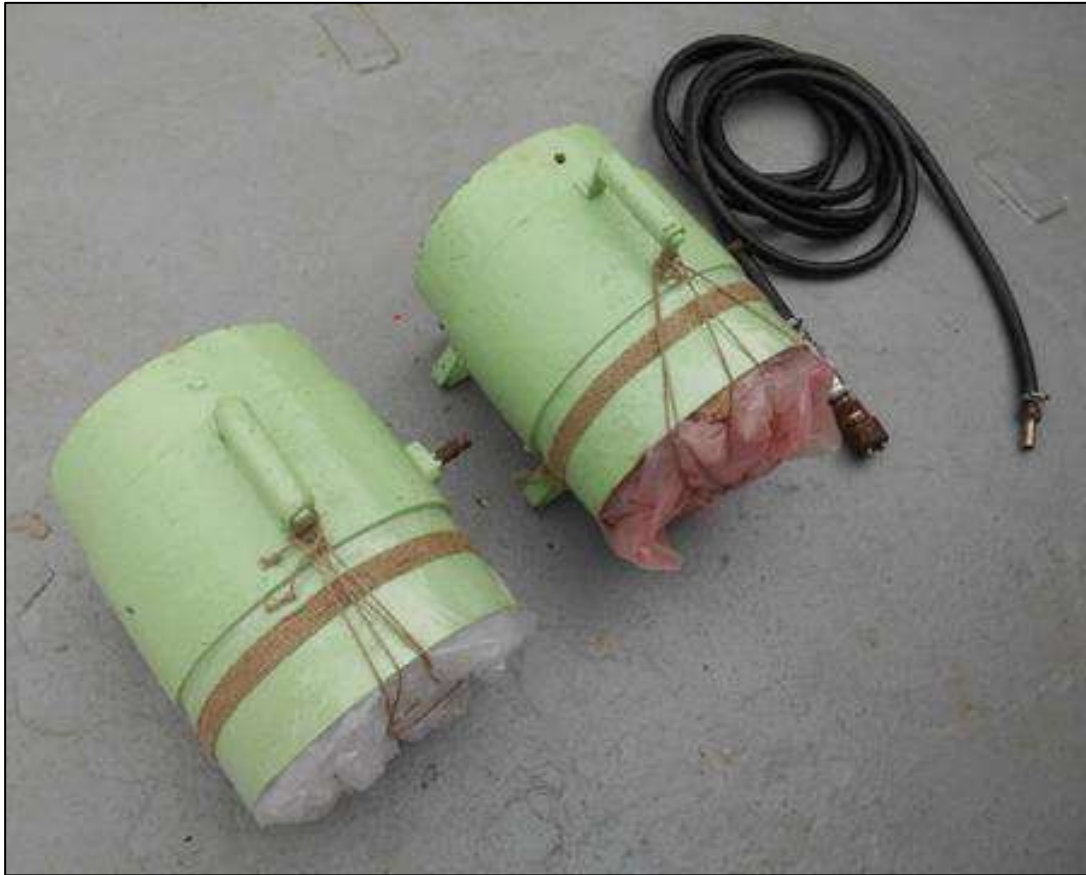
**Figure 3: Portable ventilation fans**

According to the Tank Cleaning and Ventilation Plan, each cargo tank required six hours of ventilation by fixed fans. On discovery of the AB and painter inside cargo tank no. 5 port, a single portable fan was found running on the deck. The plastic fan's extension hose, which would have been placed inside the cargo tank through the access hatch, was entirely on deck. This must have been withdrawn from the access hatch to allow entry inside the cargo tank. It was clear that fixed ventilation had not been in used for cargo tank no. 5 port.

- .8 Ventilation of cargo tank no. 5 port was carried out using portable gas freeing fans rather than the fixed Novenco type centrifugal fan;
- .9 The officer responsible for ensuring that all parts of the entry permit were properly completed, was available neither on deck nor in the CCR during the cargo tank cleaning operations;

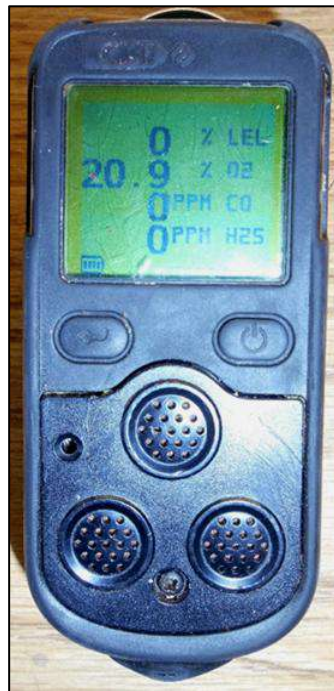
**Figure 4: GMI type PS241 gas detector**

For the measurement of tank atmosphere, *Key Fighter* carried four portable gas detectors, three for personal use when in an enclosed space. The fourth one was used with an extension hose for initial gas measurement. These were functional and mandatory for use by any person entering a cargo tank. The chief officer stated that he instructed both the AB and the painter verbally and in writing, to use personal gas detector and ventilate cargo tank no. 5 port until safe for entry. However, both the AB and the painter were not wearing their personal gas detectors when they were found inside the cargo tank.

- .6 The general risk assessment document was not signed by the deceased crew members;
- .7 Personal gas detectors were not worn by the crew members who accessed the cargo tank;
