EMSA/OP/01/2016

Study investigating cost effective measures for reducing the risk from fires on ro-ro passenger ships (FIRESAFE)

European Maritime Safety Agency
SP Technical Research Institute of Sweden AB
Bureau Veritas
Stena Rederi AB

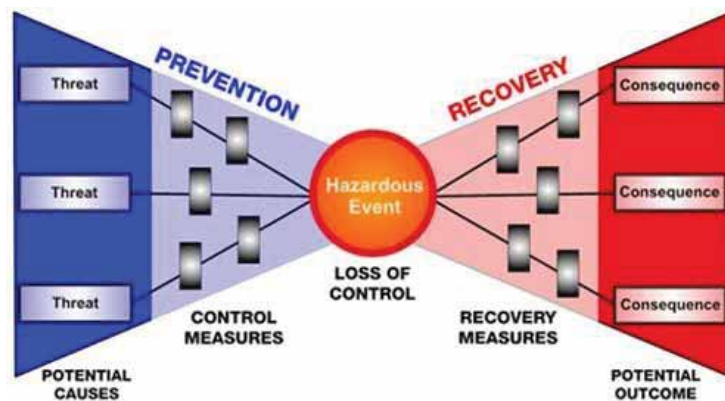
The concept used for the current Fire HazId was developed based on a well-known model in risk management called the Bow Tie model. It is a barrier risk model developed to assist the identification and management of hazards. The Bow Tie model is illustrated in Figure 2.5-1.

Figure 2.5-1. Illustration of the Bow Tie model, a barrier risk model for identification and management of hazards.

The Bow Tie model consists of different elements that build up the risk picture. The risk picture revolves around a hazardous top event. The top event is something with potential to cause harm unless it is controlled, in this case a ro-ro space fire. Focus is turned to one side at a time beginning with the threats on the left-hand side. These are potential causes for the top event which are explored through different escalation factors and control measures. Thereafter potential outcomes are investigated together with escalation factors and different recovery measures. The different control measures are barriers populated on either side of the model that are described by Table 2.5-1:

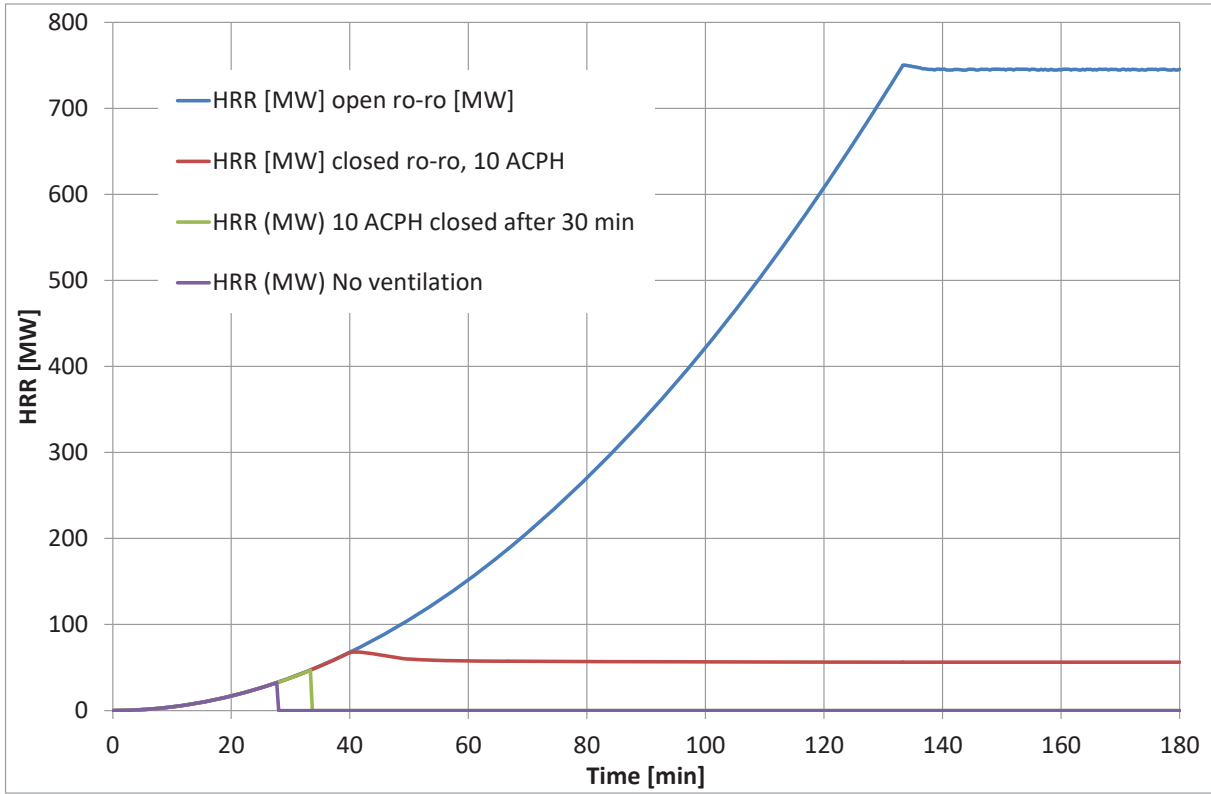
All simulations were performed assuming a medium fire growth rate and the fire was always allowed to grow until ventilation control was reached. The resulting heat release rate data is presented in Figure 2.7-2 .

Figure 2.7-2 - Heat release rates as a function of time for varying levels of ventilation

It is not obvious that a ro-ro deck fire will continue to grow until ventilation control is reached. However, Figure 2.7-32 clearly shows that the natural ventilation available on the open ro-ro deck will not be a limiting factor for the fire development before it reaches catastrophic dimensions that seriously threatens the entire ship is reached. A more detailed plot of the first 60 minutes of the same results is shown in Figure 2.7-3.

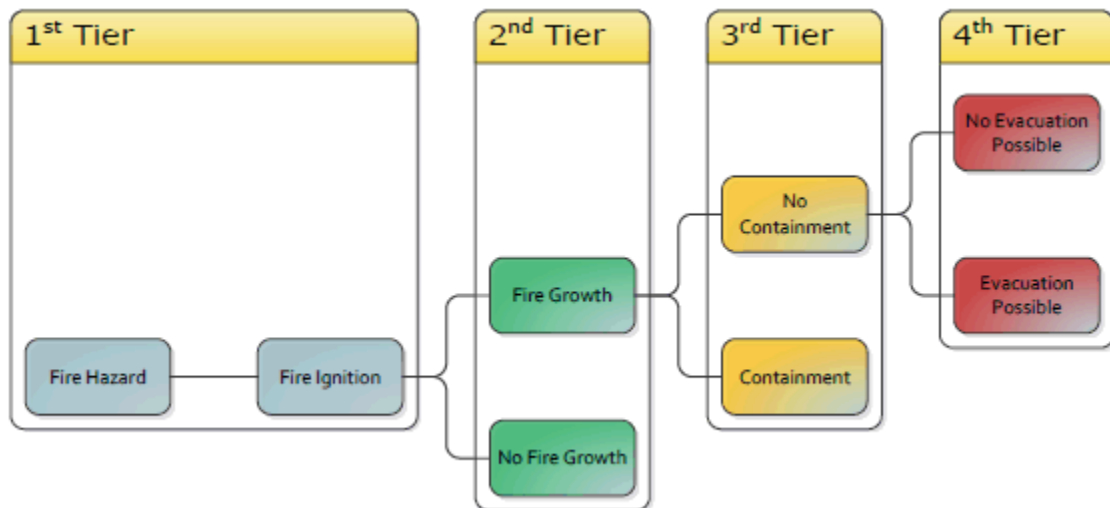
Based on the information that has been provided by EMSA stemming from the work of the GoE regarding the structure of the risk model, as well as the hazard identification (see Section Fire hazards/risks) and the fire scenarios identified (see Section Development of fire scenarios) in the previous step, a suitable risk model has been developed. Figure 2.8-1 provides the chain of event as provided by EMSA, which is composed of 4 tiers and is applicable to any spaces.

Figure 2.8-1: Fire risk model (extracted from document: 1st Correspondence of the Group of Experts on fire on ro-ro decks, EMSA, 2015).

This chain of event allows the identification of pivotal events which affect the outcome of different fire on ro-ro deck scenarios.

It should be noted that the fire risk model, as provided by EMSA, does not explicitly mention fire extinguishing. This is included within the 2nd tier along with fire detection.

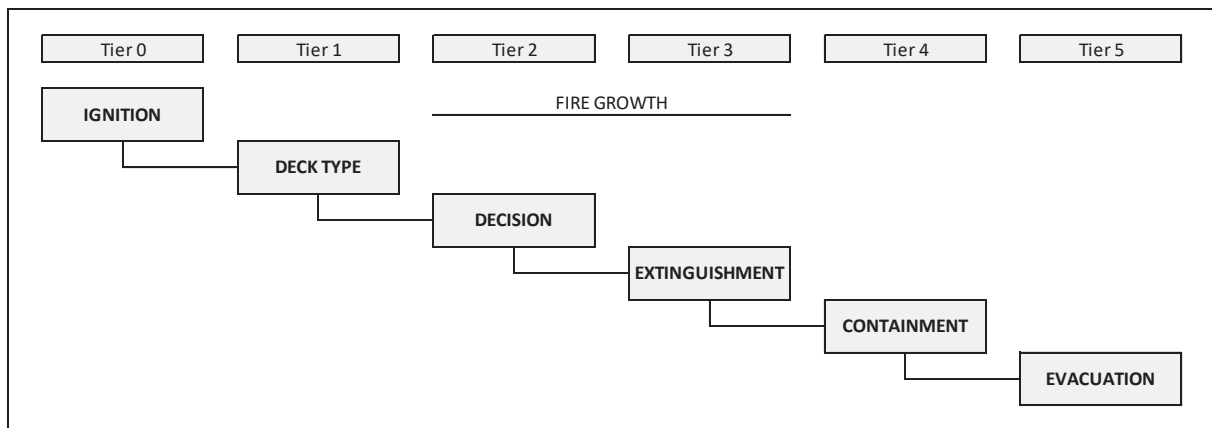
Therefore, for the purpose of the study, the chain of event has been modified as shown in Figure 2.8-2. The fire growth tier has been expanded into Decision (which include the detection and decision time) and Extinguishing. Both tiers are further explained in the following.

Figure 2.8-2: Fire risk model as modified for the FIRESAFE study.

It can be noted that compared to the fire risk model provided by EMSA, a tier has been added to consider the deck configuration on which the fire started. This tier is further explained in the following.

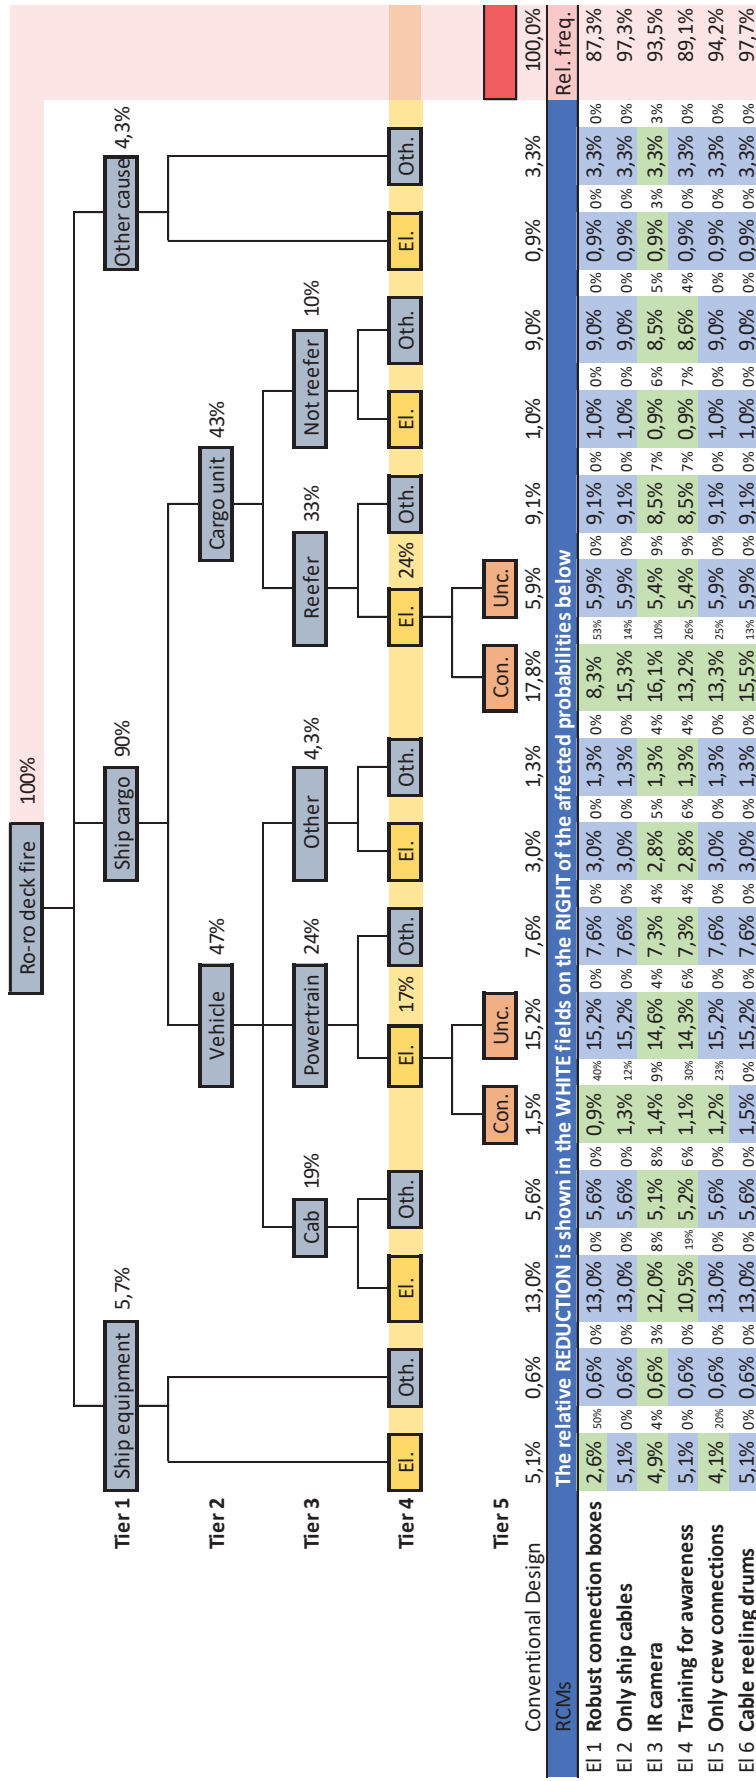
Figure 3.4-2. Fault tree risk model for electrical fire as ignition source with estimated effects of RCOs.

The list with the RCOs, affected nodes, important factors to consider, and the average values of the estimations are presented in Figure 3.4-1. The averaged estimated effects of the RCOs were linked to the risk model for electrical ignition sources on ro-ro deck, as illustrated in Figure 3.4-2. The concluding effects on the probability and frequency of fire and fire with electrical ignition source are presented, respectively, in Table 3.4-1.
